# **INDOOR AIR QUALITY ASSESSMENT**

**Forest Park Middle School  
46 Oakland Street  
Springfield, Massachusetts**

Prepared by:  
Massachusetts Department of Public Health  
Bureau of Environmental Health Assessment  
July, 2000

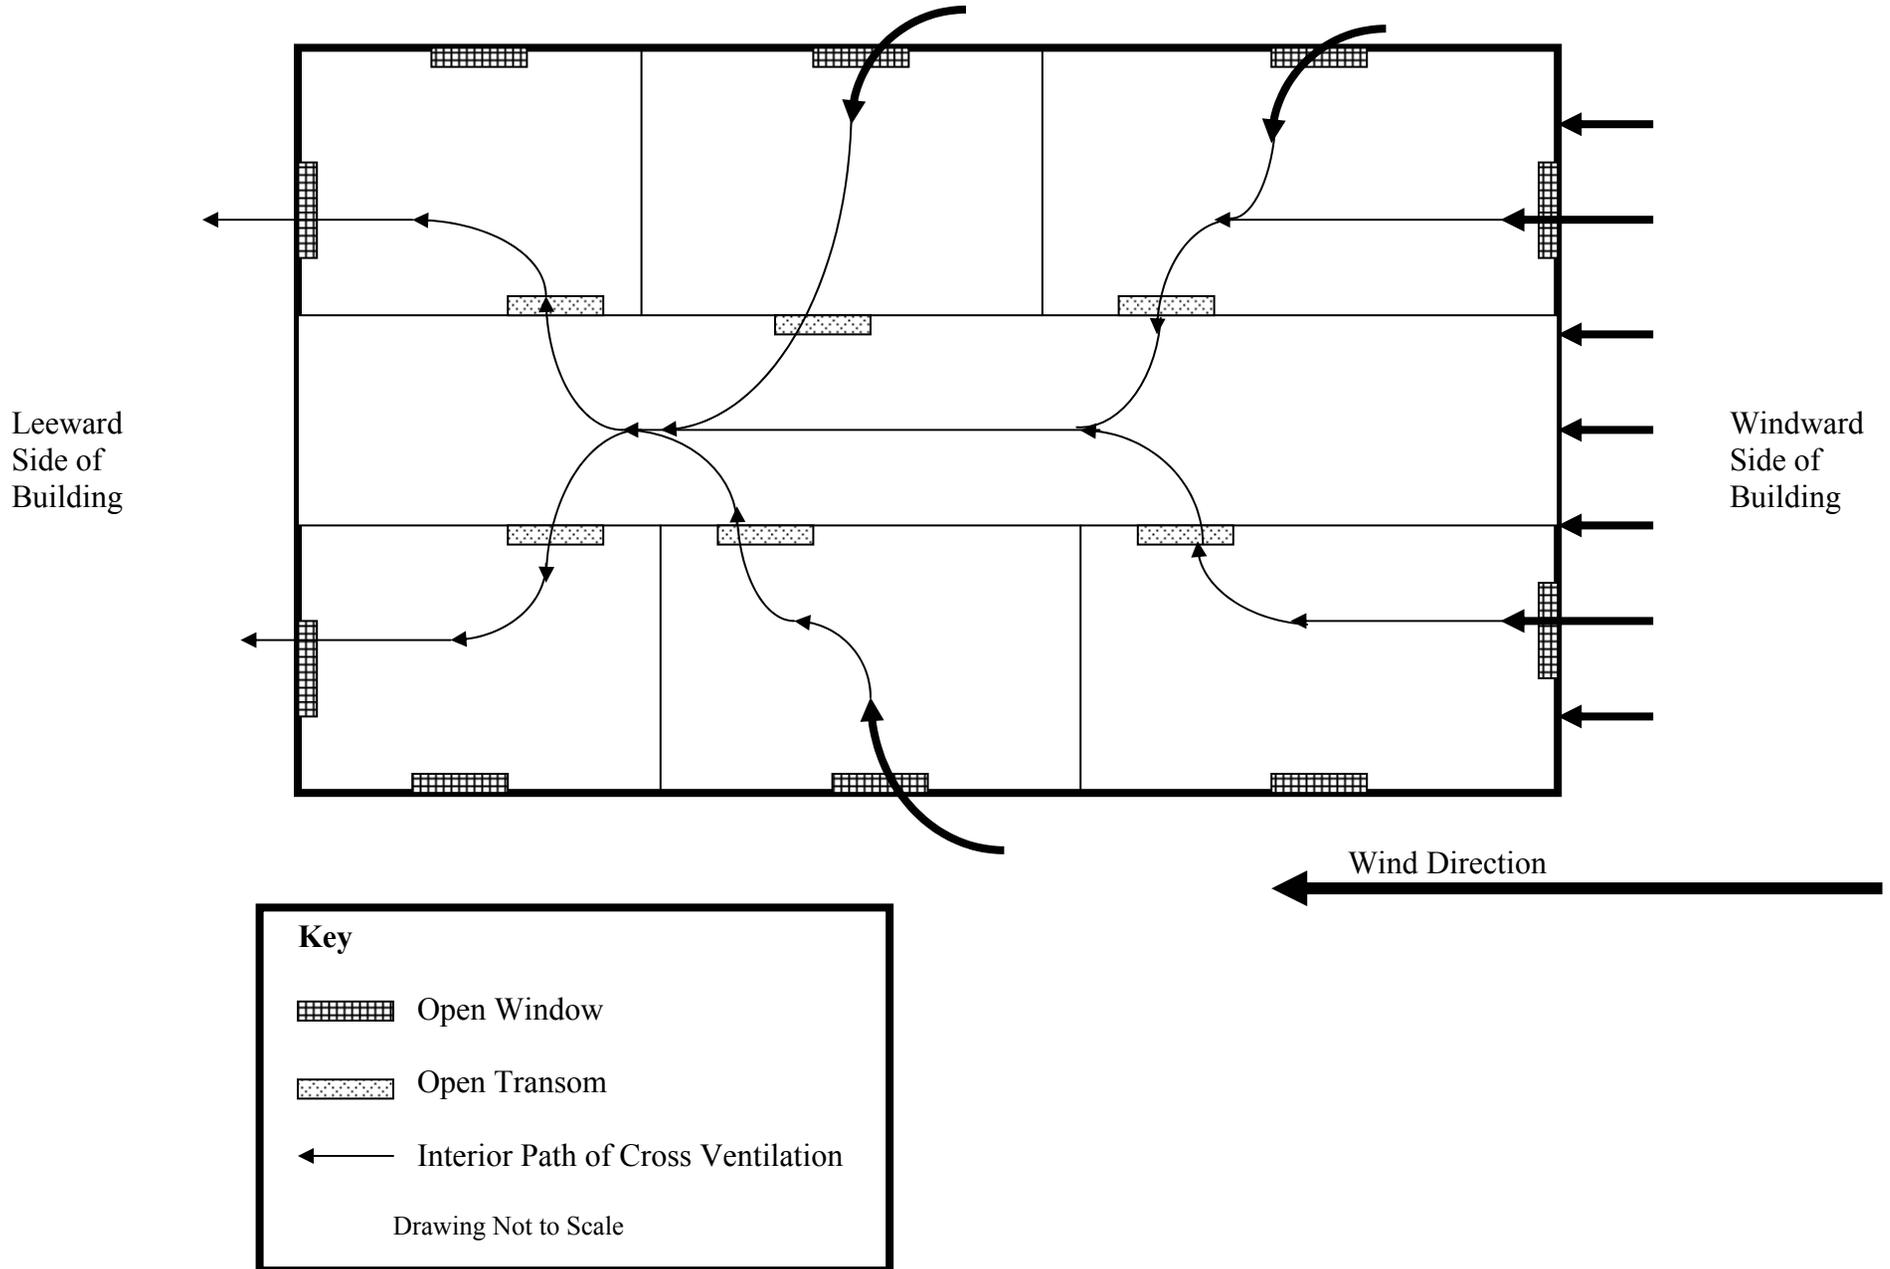
Figure 1

During summer months, ventilation within the 1919 section is controlled by the use of openable windows in classrooms. This section was configured in a manner to use cross-ventilation to provide comfort for building occupants. The building is equipped with windows on opposing exterior walls. In addition, the building has hinged windows located above the hallway doors. This hinged window (called a transom) (see Picture 7) enables the classroom occupant to close the hallway door while maintaining a pathway for airflow. This design allows for airflow to enter an open window, pass through a classroom, pass through the open transom, enter the hallway, pass through the opposing open classroom transom, into the opposing classroom and exit the building on the leeward side (opposite the windward side) (see Figure 1). With all windows and transoms open, airflow can be maintained in a building regardless of the direction of the wind. This system fails if the windows or transoms are closed (see Figure 2). Each classroom would have a long pole with a hook that was used to open the hoop latch that locks the transom closed. Most transoms in the 1919 building were closed during the assessment, which can inhibit airflow in the summer.

Cross Ventilation in a Building Using Open Windows and Transoms

3. Use transoms in the 1919 section to enhance airflow during warm weather. Be sure to close transoms at the end of the school day. To aid in the draw of fresh outdoor air in warm weather, use portable fans directing air out windows on the leeward side (opposite the windward side) of the building. Fans positioned in this manner will serve to increase the draw of outdoor air across a school floor without interfering with the natural internal airflow pattern of the building. To aid cross ventilation, open hallway doors.

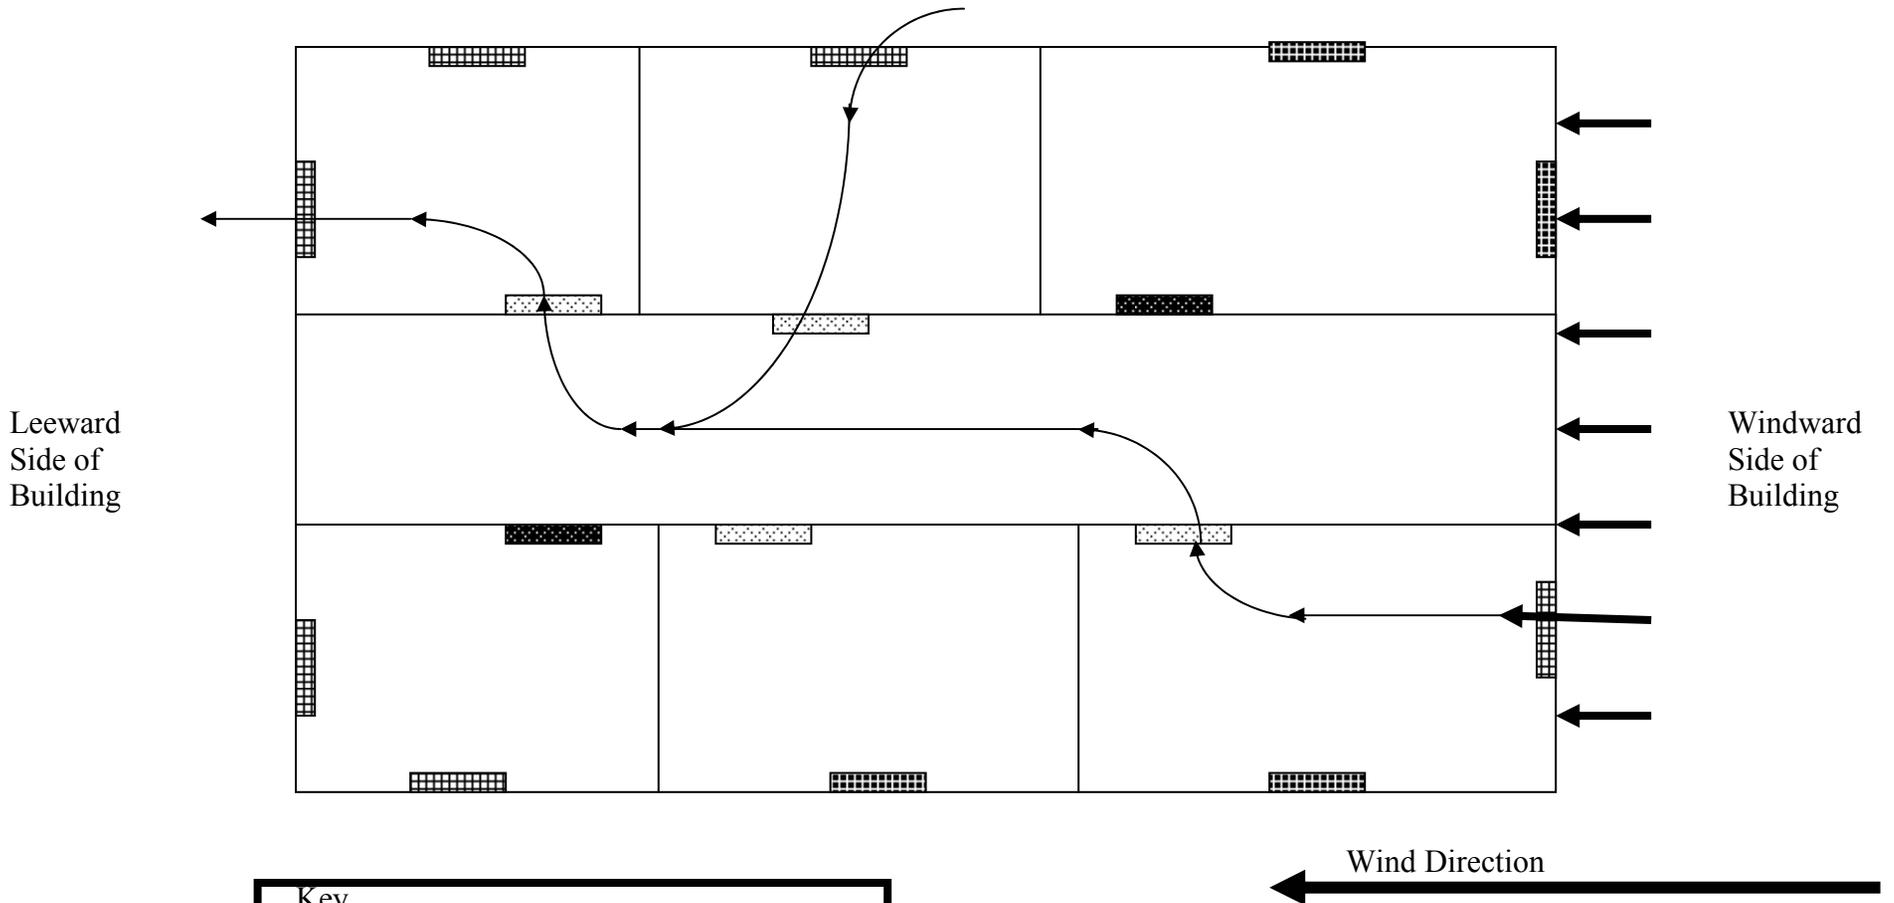
Figure 2

Inhibition of Cross Ventilation in a Building with Several Windows and Transoms Closed

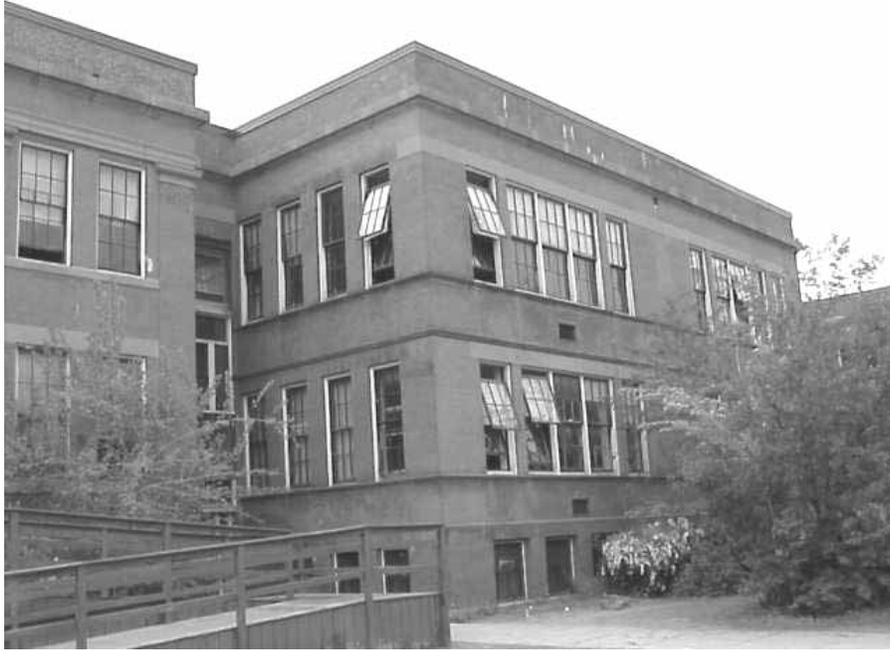
**Picture 1**

The school is a two-story brick structure that was built in two stages. The original school building was constructed in 1897 (see Picture 1). A wing was added to the building in 1919 (see Picture 2). Windows are openable throughout the building. Energy efficient windows were installed in the north wall of the building (see Picture 3).

**The 1897 Building**

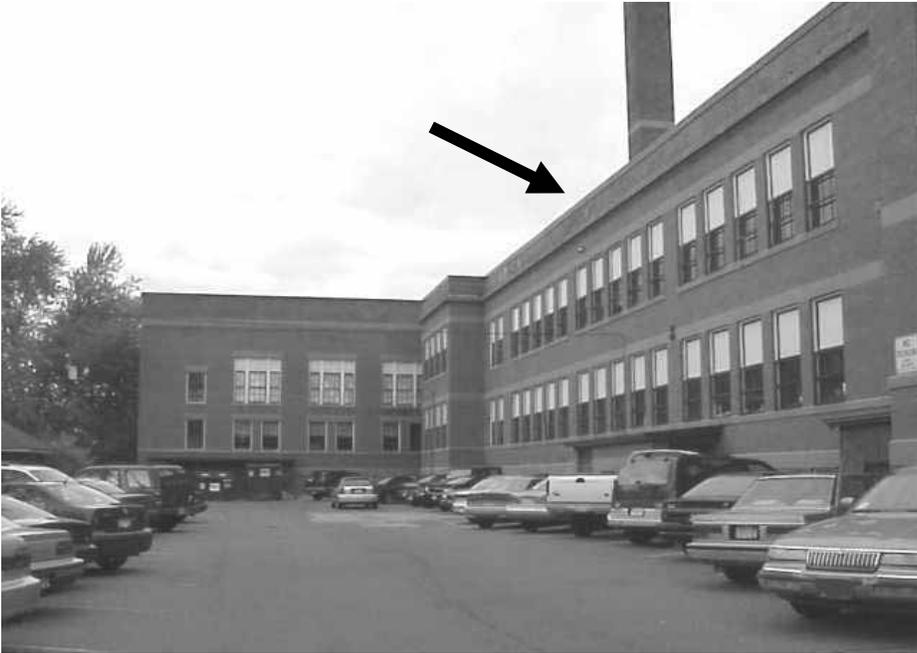
**Picture 2**

**The 1919 Wing**

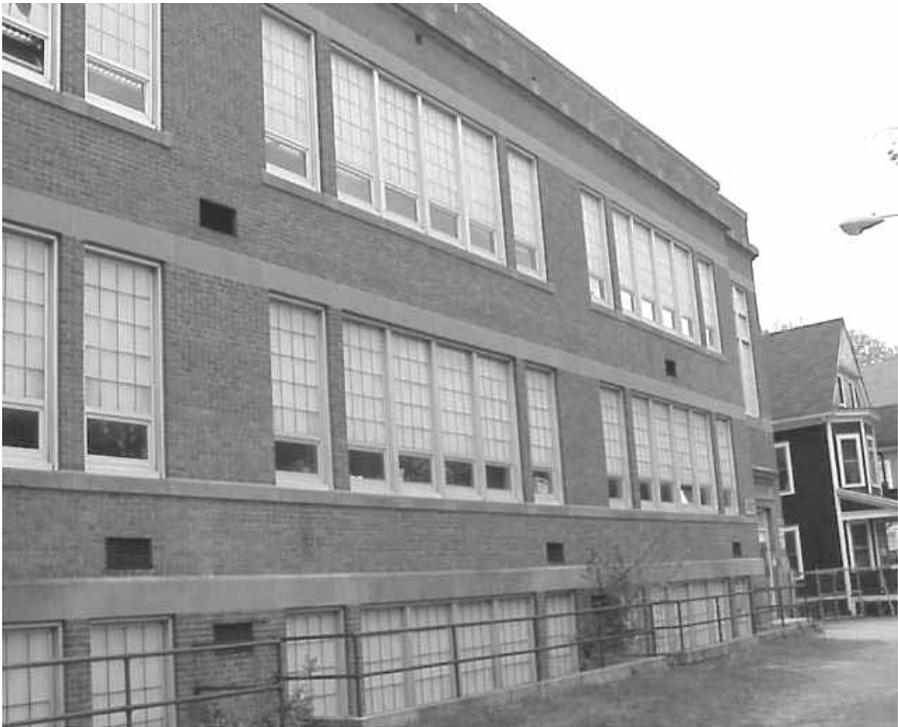
**Picture 3**

**Energy Efficient Windows of the 1897 Wing**

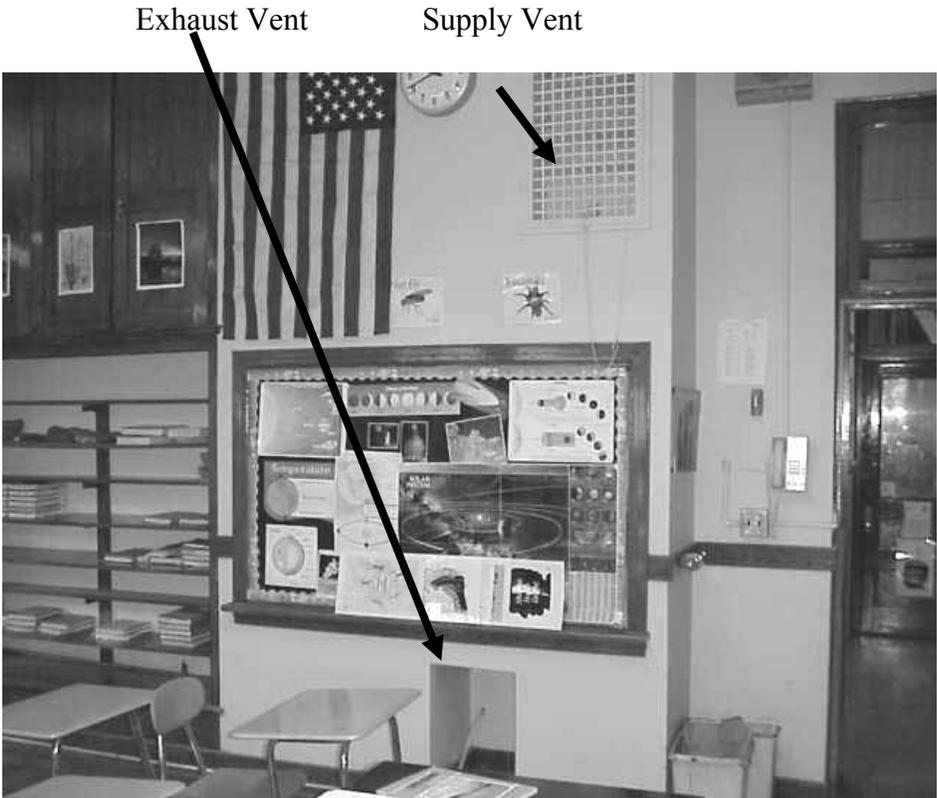
Picture 4

Exhaust ventilation is drawn from the classroom into an ungrated hole located at floor level (see Picture 4). A flue located inside the duct controls airflow. Above the flue is a heating element, that creates ventilation in the same method as the fresh air supply system.

Configuration of the Gravity Ventilation System in the 1919 Wing

6. Repair the pulley chain/louver door systems in vents to provide ventilation as designed. Repair the hinged-pulley system windows to provide fresh air to 1919

classrooms. Consider restoration of the building's original floor vent system to improve air movement, which would consist of removal of plugs from cool air vents on first floor. Regulate airflow in these classrooms with the use of the gravity/natural ventilation system and windows to control for comfort.

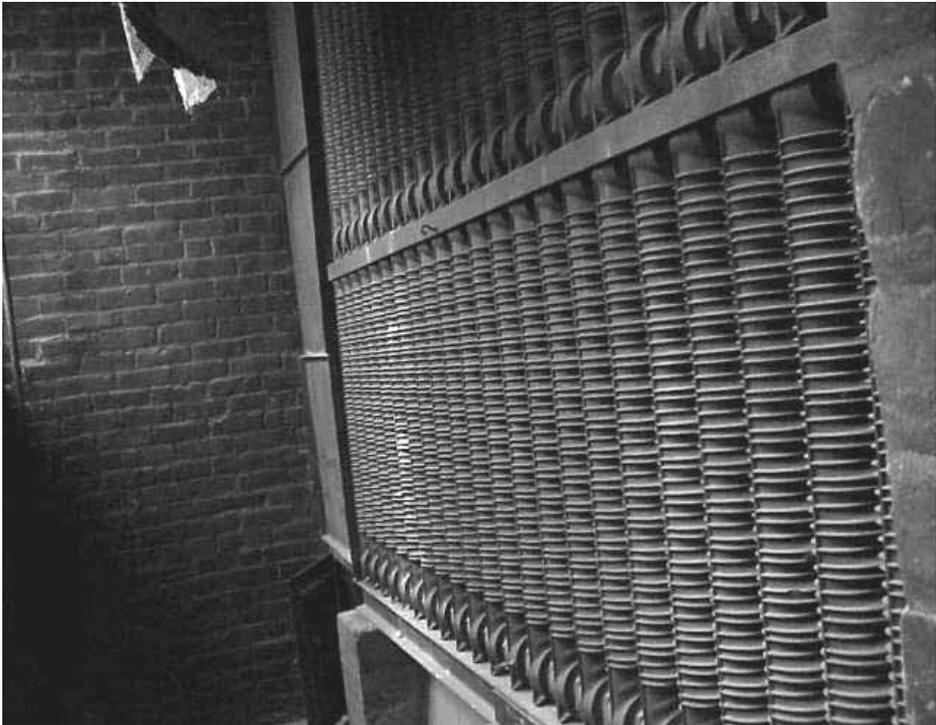
**Picture 5**

Each wing is outfitted with different types of ventilation systems. The 1919 section of the building is provided with a natural/gravity ventilation system, to be used in combination with openable windows. Ventilation is provided by a series of louvered vents. Each classroom has an approximately 3' x 3' grated air vent in the center of an interior wall near the ceiling (see Picture 4), which is connected by airshafts to two separate vaults in the basement. Fresh air movement is provided by the stack effect. The heating elements (see Picture 5) located in the basement heating vault warm the air, which rises up the fresh air ventilation ducts. As the heated air rises, negative pressure is created, which draws outdoor air through windows into the basement heating vault (see

**Heating Elements in the Basement Heating Vault**

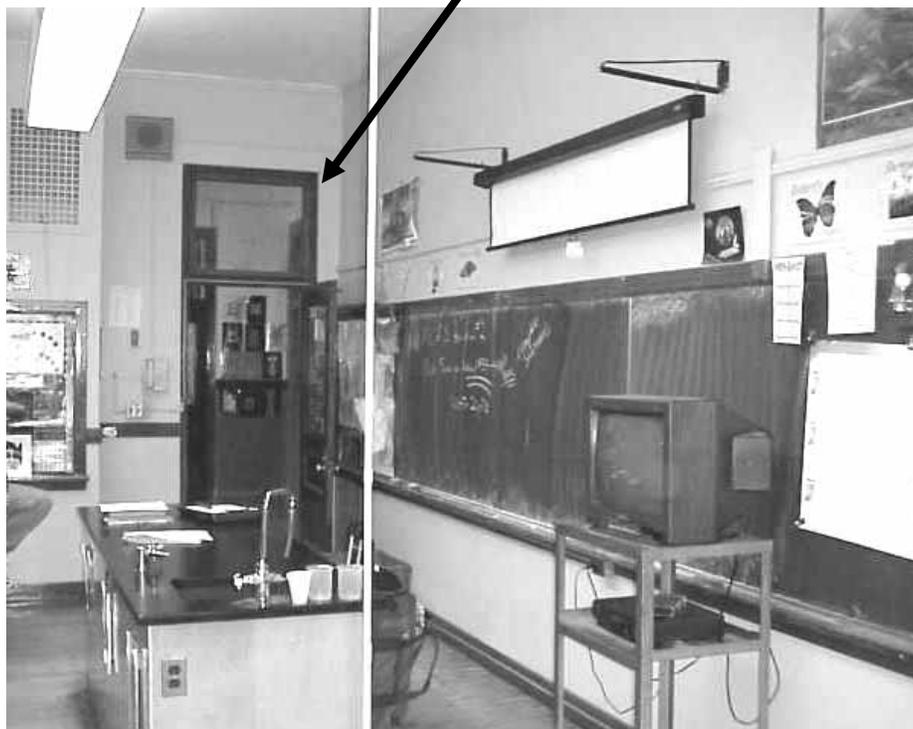
**Picture 7**

**Transom above Hallway Door in 1919 Wing**

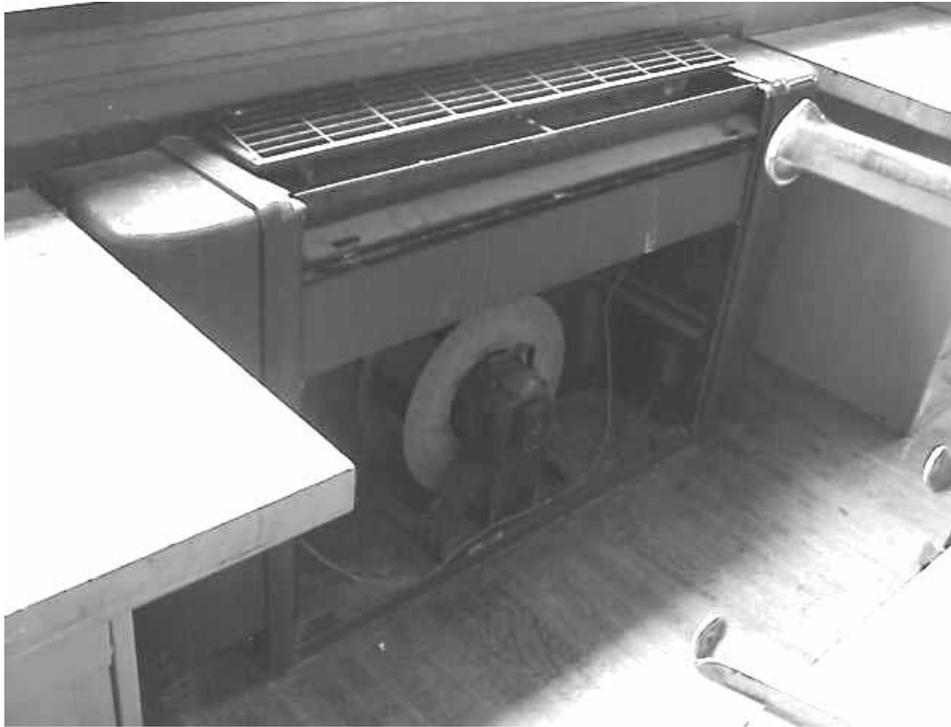
**Picture 8**

The 1897 section has fresh air supplied by a unit ventilator (univent) system (see Picture 8). Within each univent is a fan (see Picture 9). Opposite this fan is a set of moveable louvers through which fresh air enters the univent (see Picture 10). Each of these louver systems appears to be set by hand to regulate fresh air intake into the univent. In order for univents to function as designed, univent fresh air diffusers and return vents must be unblocked and remain free of obstructions. Importantly, these units must be activated and allowed to operate.

**Univent in the 1897 wing with its Front Cover Removed**

2. Survey 1897 classrooms for univent function to ascertain if an adequate air supply exists for each room and make univent repairs as needed. Hand set fresh air louvers to increase the percentage of fresh air intake if necessary. Consider consulting a heating, ventilation and air conditioning (HVAC) engineer concerning the calibration of univent fresh air control dampers school-wide.

4. Operating the univent system during hot weather will supplement the use of open windows. If sections of the ventilation system do not operate, the placement of fans to exhaust air from the leeward side of a building with hallway doors open may be employed. With this type of ventilation system, univents should be operating during school hours with the fresh air damper open 100% to enhance airflow into classrooms. This converts each univent into a large fan system.

5. To maximize air exchange, the BEHA recommends that univents operate continuously during periods of school occupancy independent of classroom thermostat control.

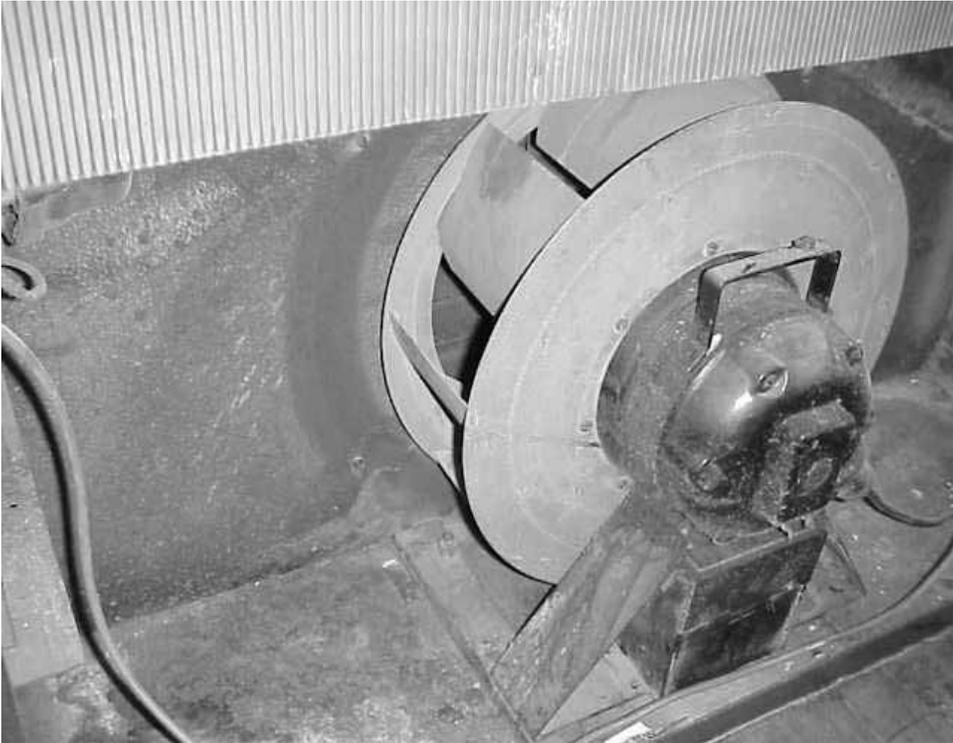
**Picture 9**

**Fan Inside of Univent**

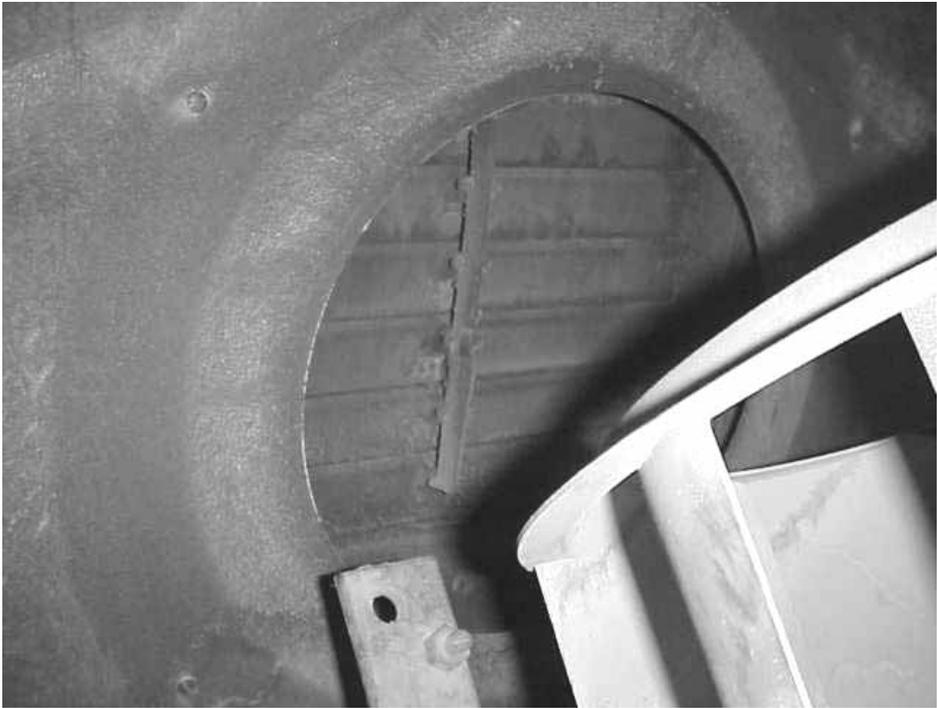
**Picture 10**

**Fresh Air Supply Vent Moveable Louvers behind Univent Fan**

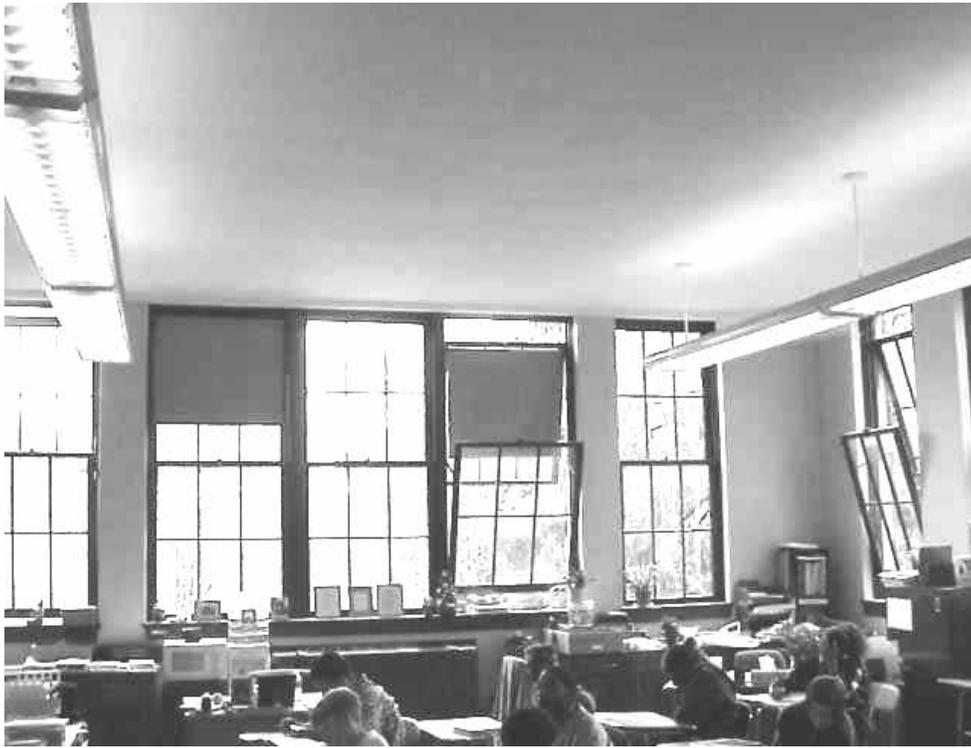
**Picture 11**

To provide ventilation during warm weather, the 1897 wing is also equipped with openable windows (see Picture 11). Since the exhaust ventilation system is non-mechanical, no airflow is created by this system once the boiler system is deactivated. Therefore, to increase airflow, cross ventilation using windows would be used to create airflow in this section of the building. Doors in the 1897 section are not equipped with transoms. In order to create cross ventilation, classroom hallway doors and windows need to be opened. Classroom doors were closed in a number of areas at the time of the inspection.

**Openable Windows in the 1897 Wing**

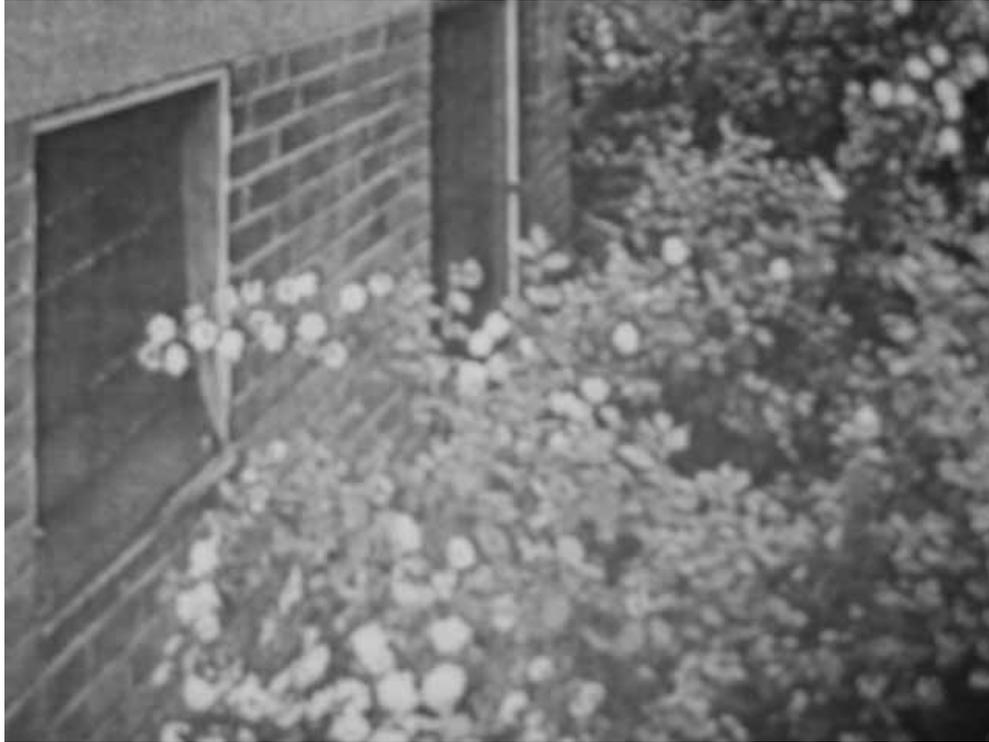
**Picture 12**

Shrubbery in direct contact with the exterior wall brick was noted in several areas around the building (see Picture 12). Shrubbery can serve as a possible source of water impingement on the exterior curtain wall due to the location of plants and tree branches growing directly against the building. Plants retain water and in some cases can work its

way into mortar and brickwork causing cracks and fissures, which may subsequently lead to water penetration and possible mold growth.

**Plants Impinging on 1919 Wing Exterior Wall**

11. Reduce/trim or remove plants that are growing against the exterior brick curtain wall.
12. Repair/replace water damaged plaster, examine surrounding non-porous areas for mold growth and disinfect with an appropriate antimicrobial if necessary.
